# CoreVault Data Center Phase II ELECTRONIC LEAK DETECTION REPORT

ASTM-D 7877 Compliant

| Property Name | CoreVault Data Center Phase II |
| Report Date | March 14, 2025 |

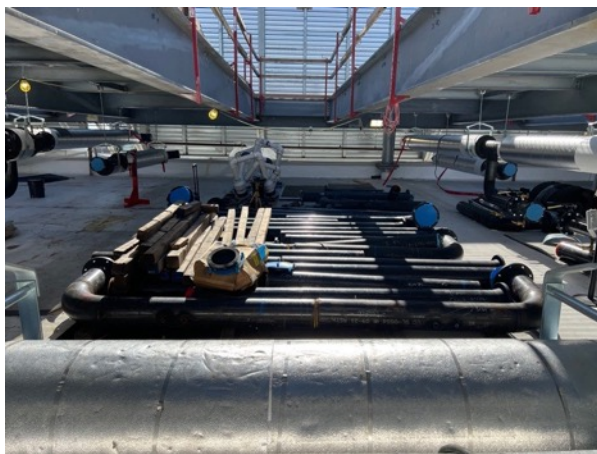
- Numerous areas on the roof had materials stored by other trades. Upon testing adjacent to these areas, both Summit Roofing and Apex Construction relocated materials so testing could be completed.
- Debris including pebbles, fasteners, and metal shavings were present throughout the roof area. This debris should be removed prior to membrane traffic; failure to do so could result in new breaches.
- Other trades are still completing work on the roof. The roofing membrane should be protected while other trades are active, or future breaches could occur.

**Representative Condition — Areas with Stored Materials**

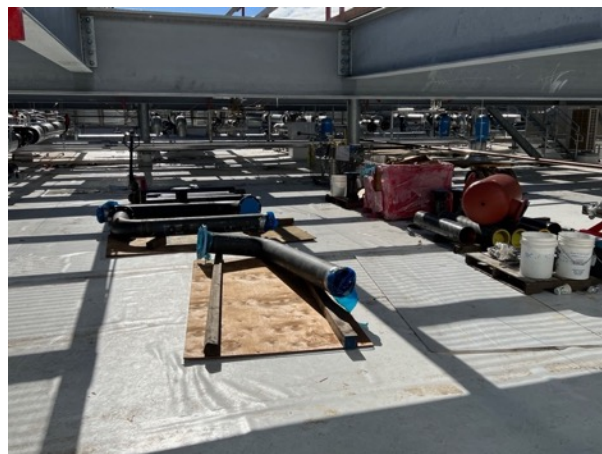
**Representative Condition — Areas with Stored Materials**

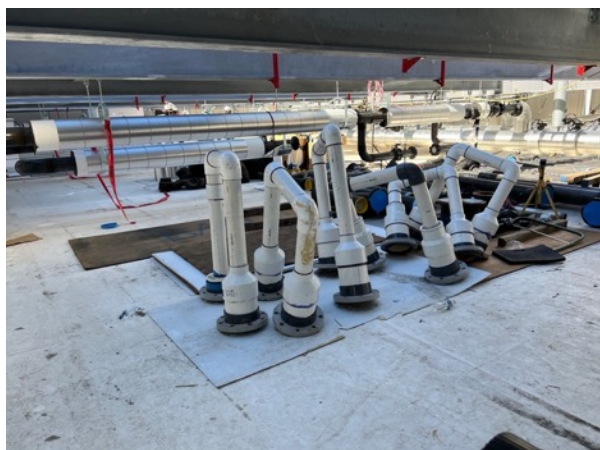
**Representative Condition — Areas with Stored Materials**

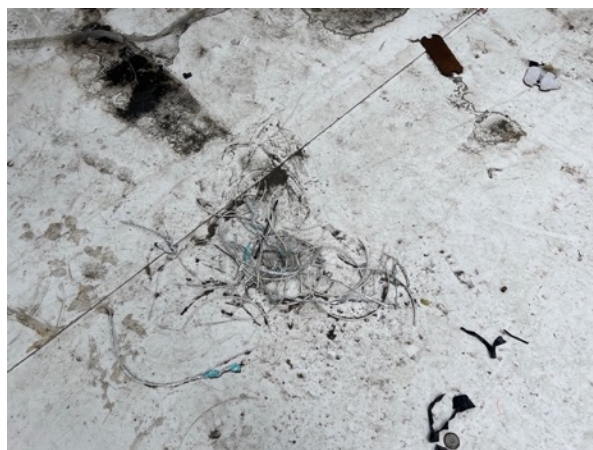
**Representative Condition — Debris Present on Membrane**

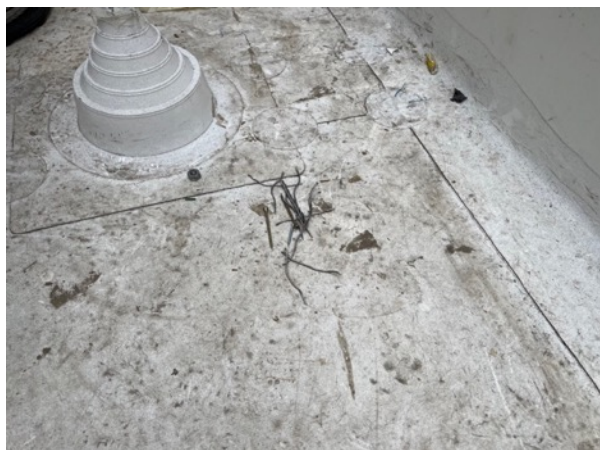
**Representative Condition — Fasteners & Metal Shavings on Membrane**

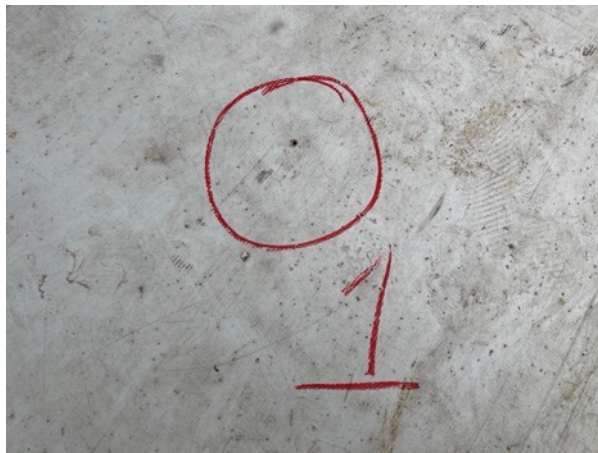
**Breach 1 — (54', 13')**

| Breach ID | Coordinates (X', Y') | Repair Status |
|---|---|---|
| 1 | 54', 13' | Pending Repair |

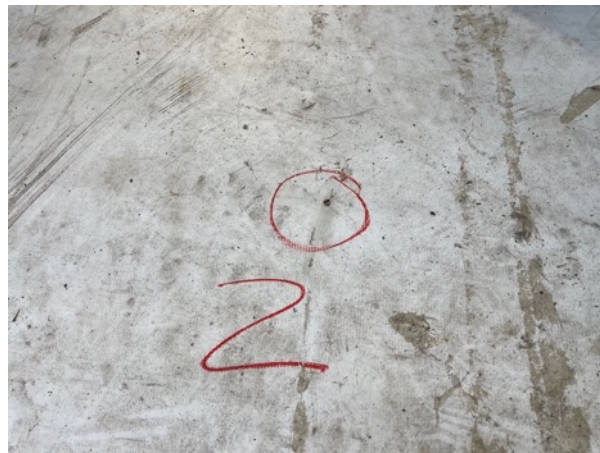
**Breach 2 — (9.5', 74')**

| Breach ID | Coordinates (X', Y') | Repair Status |
|---|---|---|
| 2 | 9.5', 74' | Pending Repair |

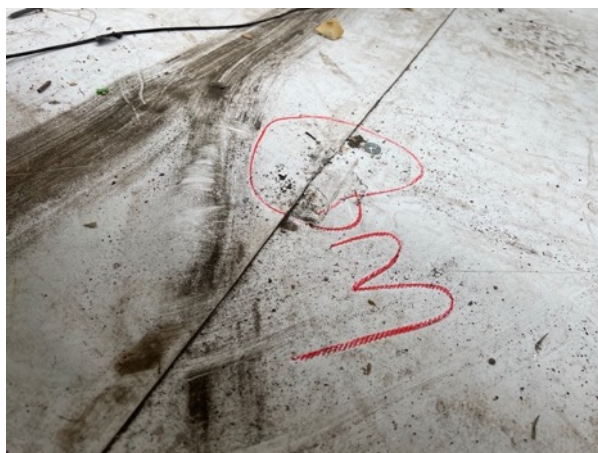
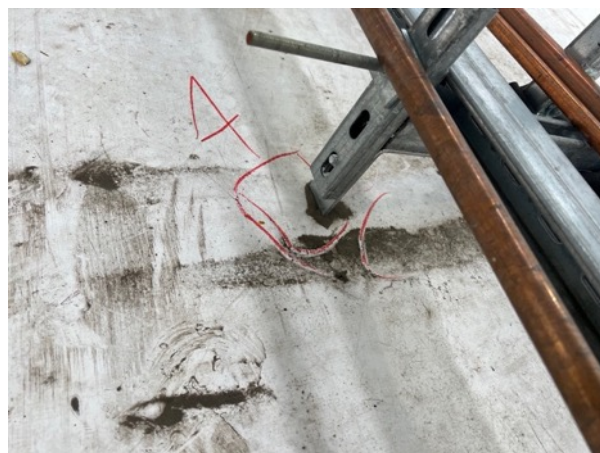
**Breach 3 — (26', 100')**

| Breach ID | Coordinates (X', Y') | Repair Status |
|---|---|---|
| 3 | 26', 100' | Pending Repair |

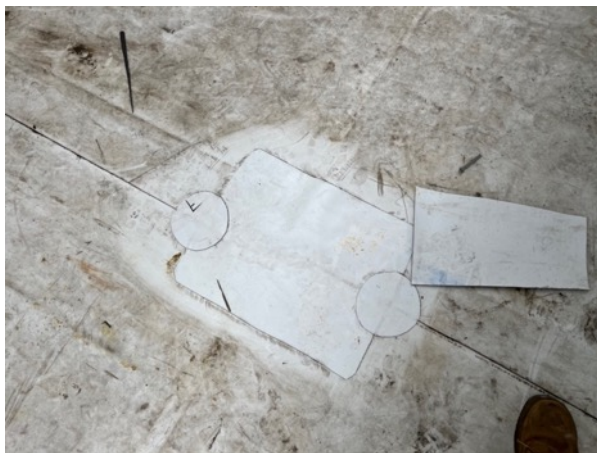
**Breach 6 — (81', 129.5')**

| Breach ID | Coordinates (X', Y') | Repair Status |
|---|---|---|
| 6 | 81', 129.5' | Pending Repair |

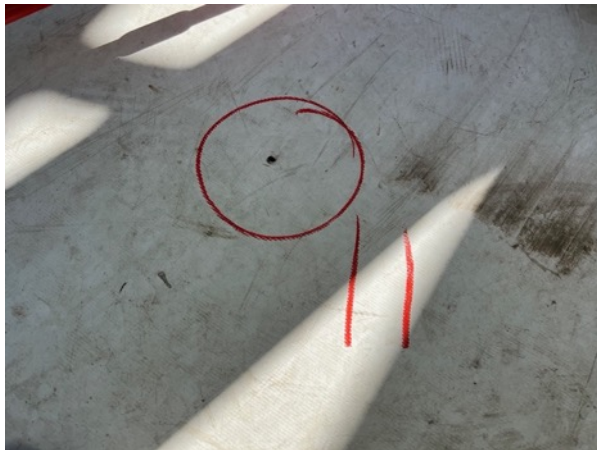
Breach 11 — (227.5', 15')

| 11 | 227.5', 15' | Pending Repair |

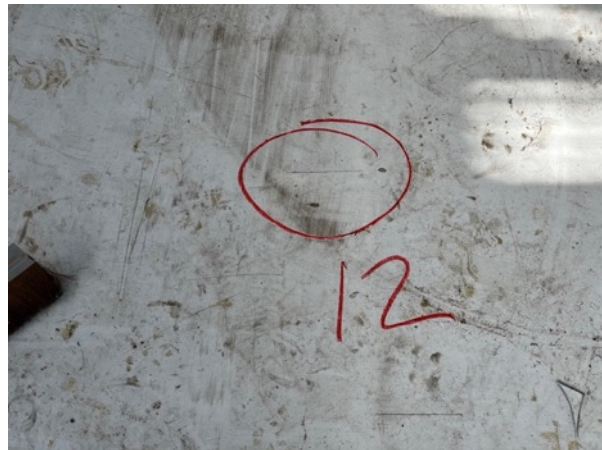
Breach 12 — (213', 42')

| 12 | 213', 42' | Pending Repair |

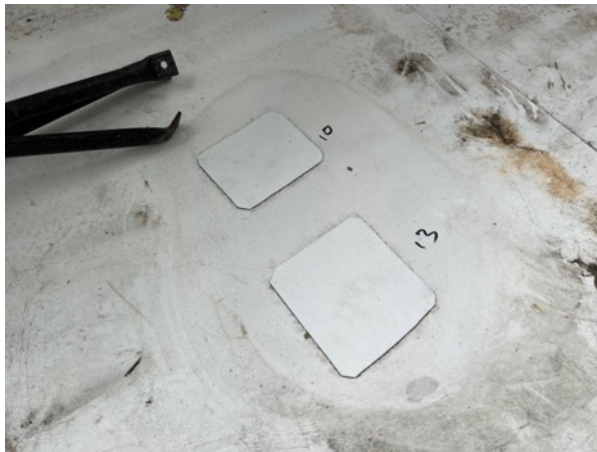
Breach 13 — (95.5', 13.5')

| 13 | 95.5', 13.5' | Pending Repair |

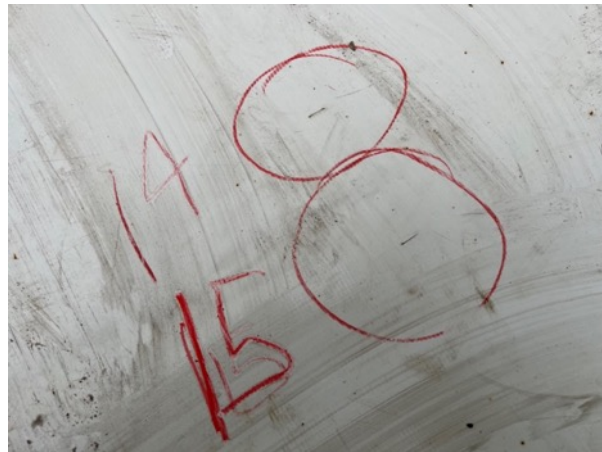
Breaches 14–17 — (155', 3') — View A

| 14 | 155', 3' | Pending Repair |
| 15 | 155', 3' | Pending Repair |
| 16 | 155', 3' | Pending Repair |
| 17 | 155', 3' | Pending Repair |
